## Scanning Glenwood Canyon

In 2010 a massive rockslide closed the busy Interstate I-70 Highway in Glenwood Canyon, 160 miles west of Denver, Colorado.

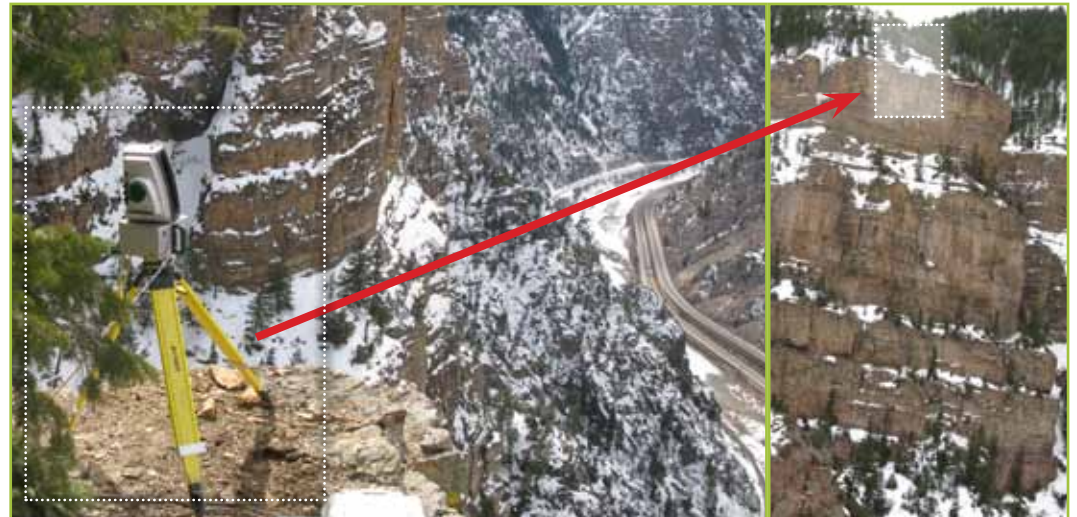
*I-Site 8800 laser scanner overlooking rockslide with the arrow pointing to the position of scanner on canyon wall rim*

THE AREA TO BE MEASURED WAS NEARLY 3000FT (ABOUT 900M) FROM THE VANTAGE POINT. THE I-SITE 8800 RANGE EASILY COVERED THE AREA OF INTEREST.

A HIGH RESOLUTION SCAN WAS COMPLETED IN LESS THAN 1 HOUR.

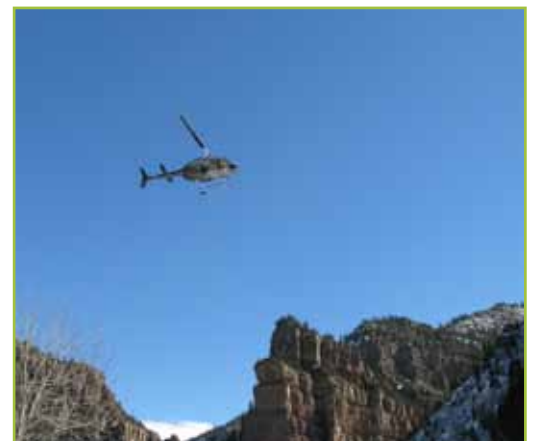
*The I-Site 8800 scanner was flown into position*

The opposite canyon wall rim gave the best view of the rock slide, but access was difficult by foot. A helicopter transported people and equipment to the top of the canyon. The area to be measured was nearly 3000ft (about 900m) from the vantage point.

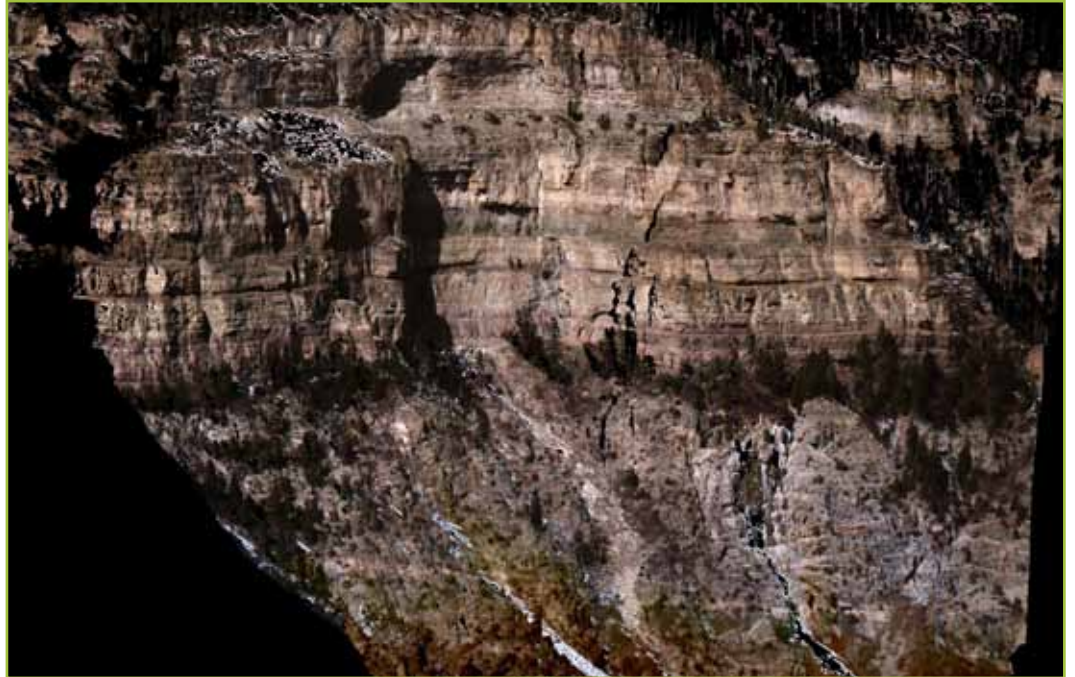
*The I-Site 8800 inbuilt camera allows 3D imagery to be captured at the same time as scanning*

The area was surveyed with the I-Site 8800, and a 3D digital terrain model was created of the scans. The model had points less than 0.5ft (0.15m) apart, with a high resolution photograph applied in I-Site automatically.

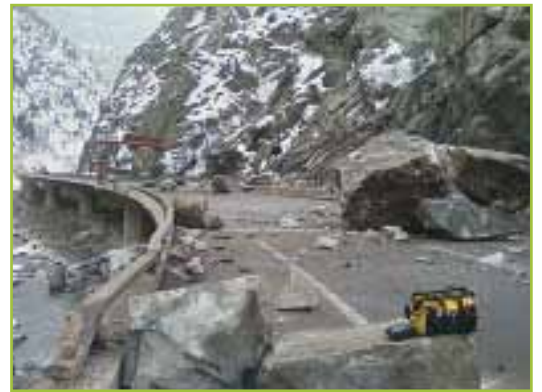
*The aftermath of the 2010 rockslide on the I-70 highway*
