## QUARRY MANAGEMENT

The Maptek I-Site™ 8800 laser scanner helped survey teams conducting safety studies at a large quarry in Leicestershire in the UK.

OAKES SURVEYS APPROACHED MAPTEK FOR HELP IN CONDUCTING SAFETY STUDIES AT THE QUARRY.

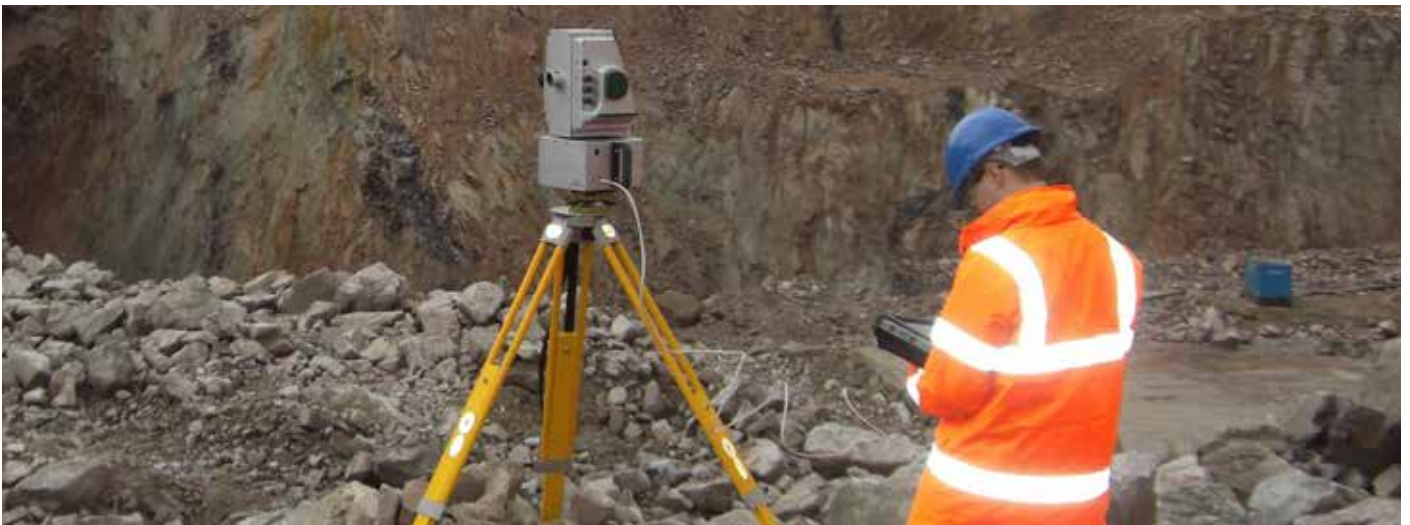
Weathering of the higher benches over decades of operation had resulted in loose rocks falling from the quarry faces to the floor.

The point cloud data was processed in Maptek I-Site Studio™ software and accurate triangulated surfaces were created. Quarry surface data was divided into panels for comparing surfaces between quarterly site surveys.

Displaying the data with a colour spectrum clearly showed the size and location of change. Areas of change down to approximately 150mm were reported, along with the location and size of the material that had fallen.

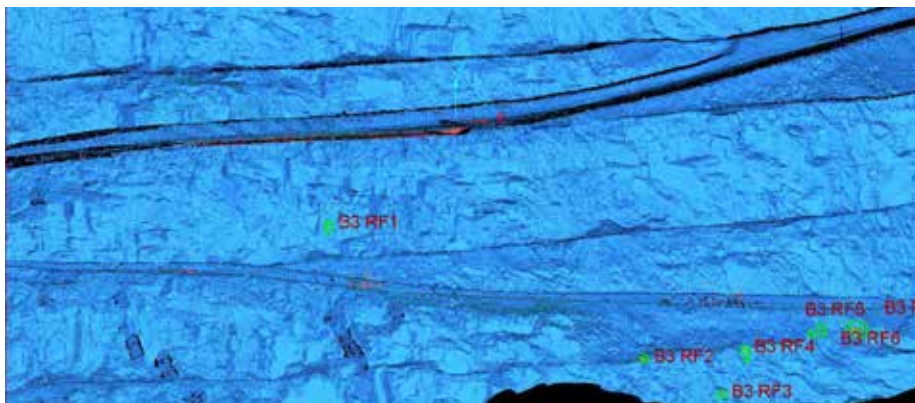
Survey data is processed and triangulated in Maptek I-Site Studio to create a surface for easy visualisation of structures and changes in quarry faces
