## Sentry aids stability monitoring

The Maptek™ I-Site™ 8820 laser scanner and Sentry software have proven their value in stability monitoring during a research and development trial in South Australia.

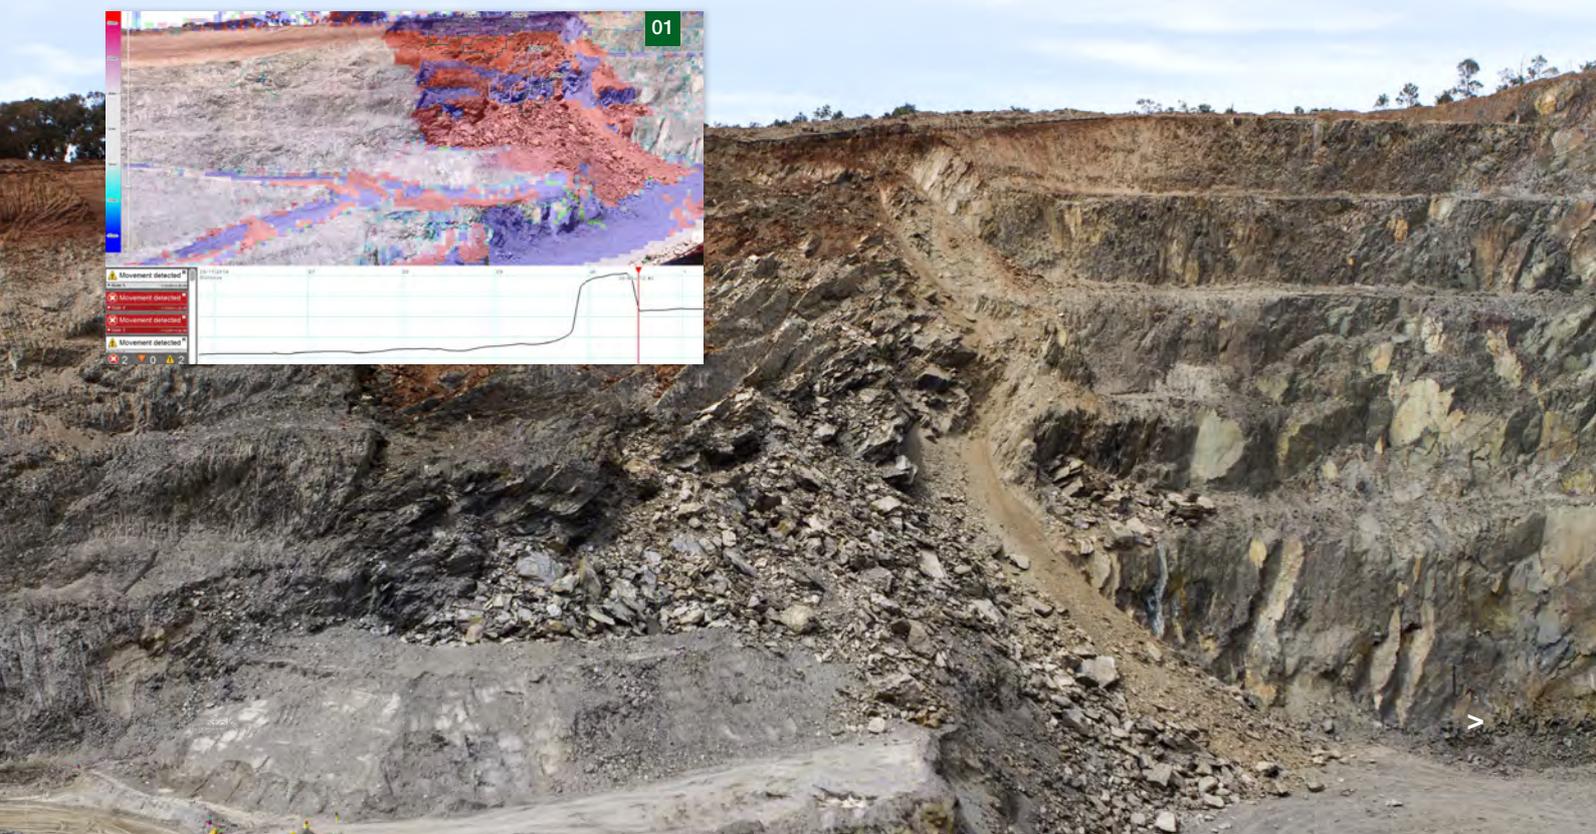
- 01 Eastern wall of the Nugent pit showing flexural toppling failure. Sentry heat map and graph clearly indicate an increased rate of movement in zones of interest
- 02 Sentry setup at Hillgrove Resources Kanmantoo Mine
- 03 Post-failure analysis of inverse velocity data shows prediction of failure 18 hours before it occurred
- 04 Pre-failure image of the pit wall
- 05 Sentry monitors movement and maps the development of scarps

A flexural topple event, in which columns of rock separated by discontinuities broke as they bent forward, occurred on November 29.

The I-Site laser scanner was used throughout the development of the toppling failure to monitor movements, starting from initial dilations through reverse scarps and to the final collapse.
